# Description of the Proposed Action and Alternatives

for the Environmental Assessment Addressing Wastewater and Stormwater Infrastructure Improvements at Cannon Air Force Base, New Mexico

Report Designation: Final Description of the Proposed Action and Alternatives (DOPAA).

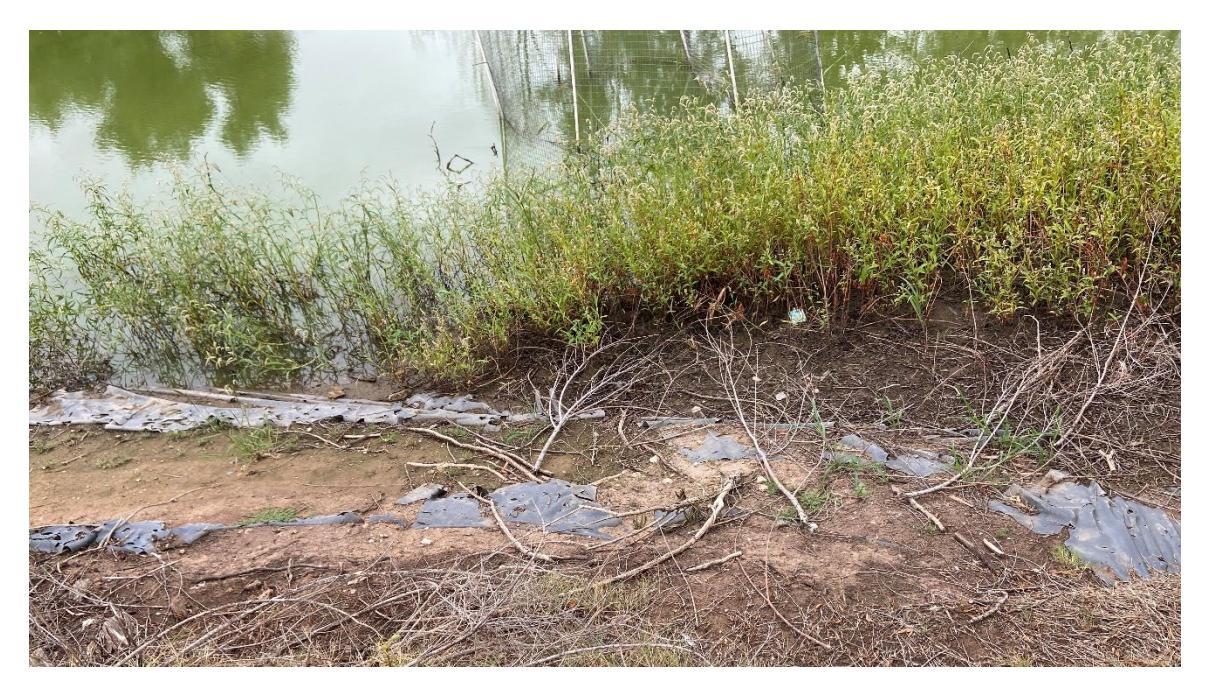
The liners in these impoundments were originally installed in 1992 and have reached the end of their life cycle. Their structural integrity has been compromised, requiring repair. The degradation, tears, and general poor condition of the liners can be seen in **Photo 2-2** (North Impoundment) and **Photo 2-3** (South Impoundment) which show damaged portions of the exposed liners. Their current condition poses a concern due to possible seepage of reclaimed water into the ground, which violates DP-873. The existing liners require replacement no later than April 2025 as indicated in the CAP required by Term and Condition 57 of DP-873 as issued by NMED. The NMED-approved CAP suggests Cannon AFB do the work in phases, similar to those listed below. However, the suggested phases are subject to change based on the final design developed by the contractor performing the work.

Photo 2-2. Degradation of the North Impoundment Liner

Phase 4: Liner Replacement. To dispose of the existing liner, it must be pulled out from the impoundment basin and cleared of loose earth, then cut into manageable pieces and placed in roll-off dumpsters for disposal. The liner would be tested and disposed of in accordance with all federal, state, and local regulations. Site preparation and liner design would follow the Groundwater Discharge Permit Guidance for Synthetically Lined Lagoons – Liner Material and Site Preparation as outlined in DP-873, as well as the Groundwater Quality Bureau's minimum requirements for synthetically lined lagoons. Impoundment grading and earthwork would be done to allow for at least 24 inches of freeboard, with inside slopes ranging from 4:1 to 3:1 (horizontal:vertical). The impoundment base would be as uniform as possible and would vary no more than 3 inches from the average finished elevation. The sub-grade would consist of sand or fine soil, compacted to a minimum of 90 percent of standard proctor density, and free from sharp rocks, stubble, and vegetation to a depth of at least 6 inches below the liner. The sub-grade surface would be smooth and dry to allow for good contact with the liner during installation. The berms of the impoundments would have a minimum width of 8 feet to allow for maintenance vehicle traffic. Lagoon design would be certified by a New Mexico professional engineer and approved by Cannon AFB and NMED prior to installation.

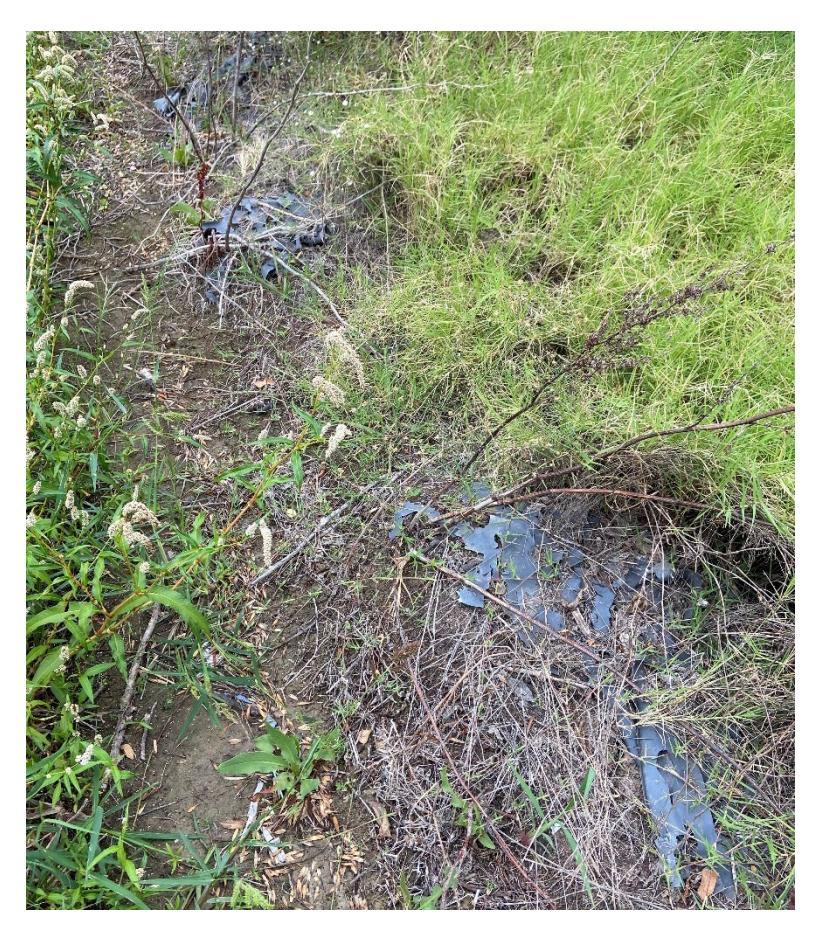
Photo 2-3. Degradation of the South Impoundment Liner

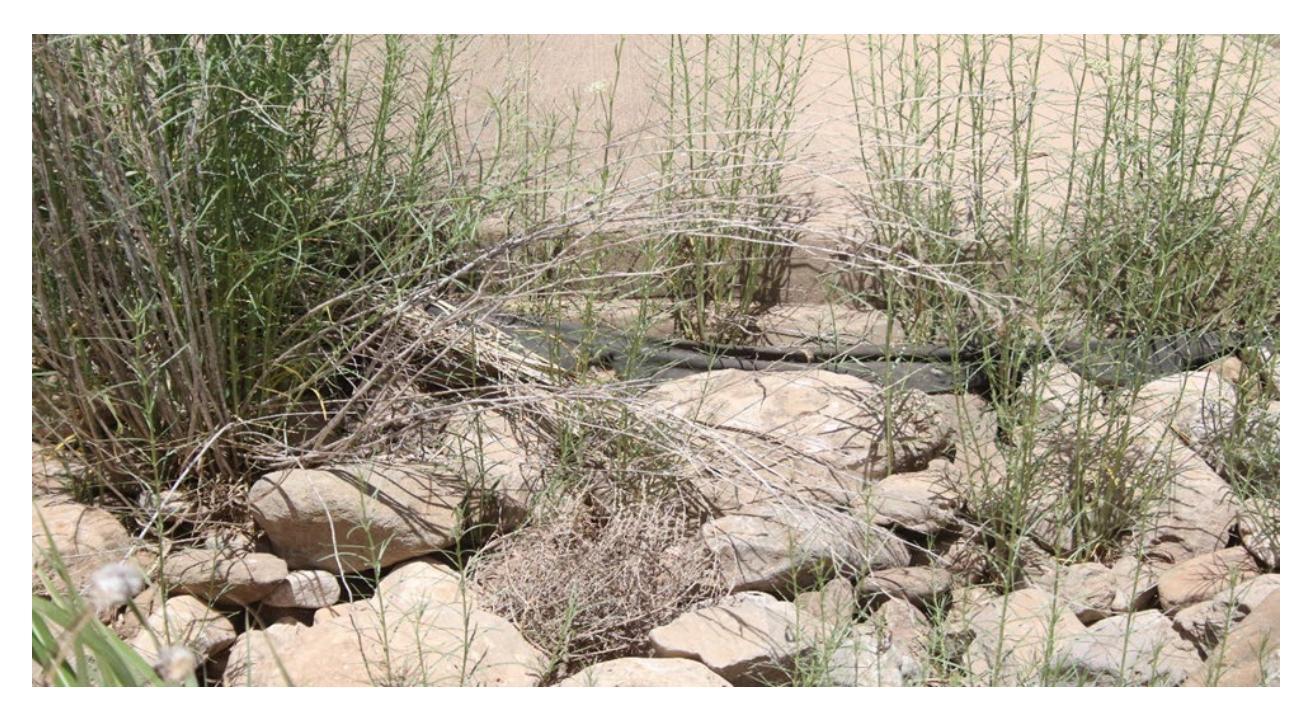
**Culvert 1.** Culvert 1 did not exhibit significant erosion issues; however, the culvert was constructed with riprap and geofabric at the apron/base of the retaining wall, which is approximately 17 feet wide. Due to the significant outflow from this culvert during rain events, the riprap has been washed away from the culvert and the geofabric left exposed, with the largest exposure being approximately 6.5 feet from the apron/base (see **Photos 2-5** and **2-6**).

Photo 2-5. Washed-Out Riprap at Culvert 1

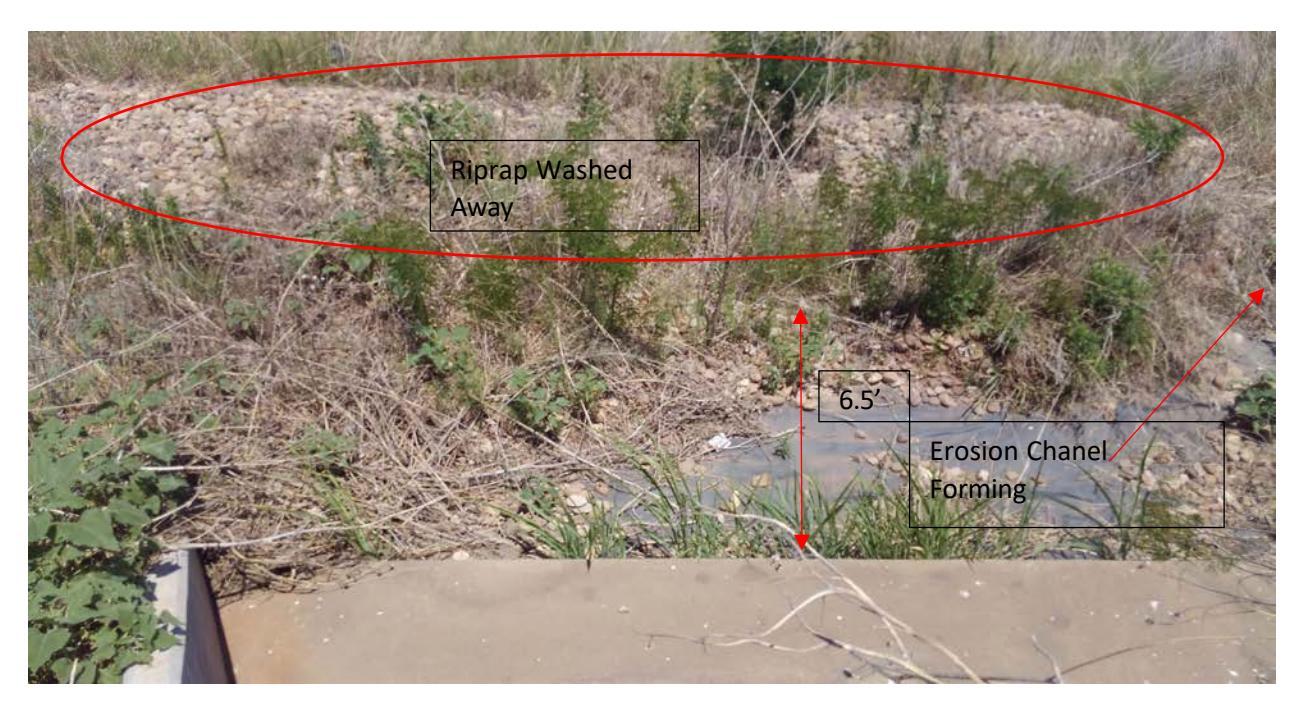
Photo 2-6. Riprap Washed Away from the Apron/Base of Culvert 1

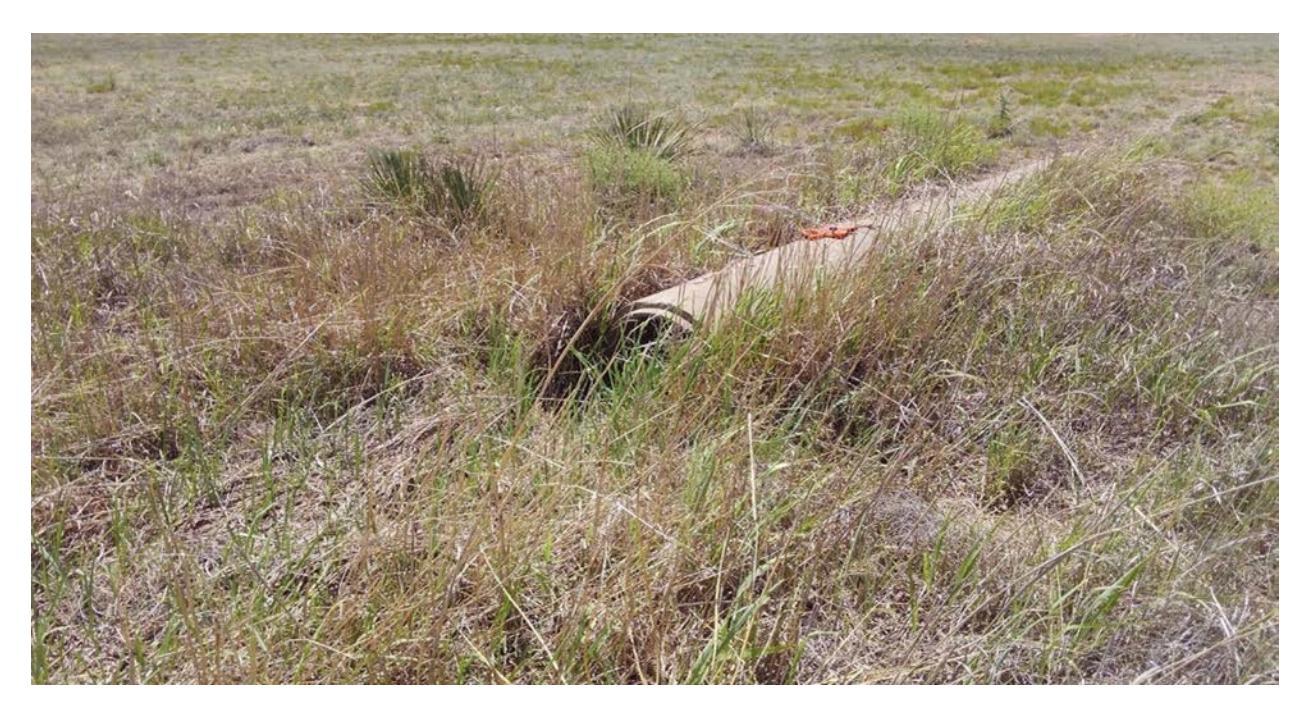
**Culvert 2.** Culvert 2 had an erosion trench with a measured depth of approximately 2.5 feet (see **Photo 2-7**) and a 2.5-inch separation in the stormwater pipeline due to undermining (see **Photo 2-8**).

Photo 2-7. Erosion Trench at Culvert 2

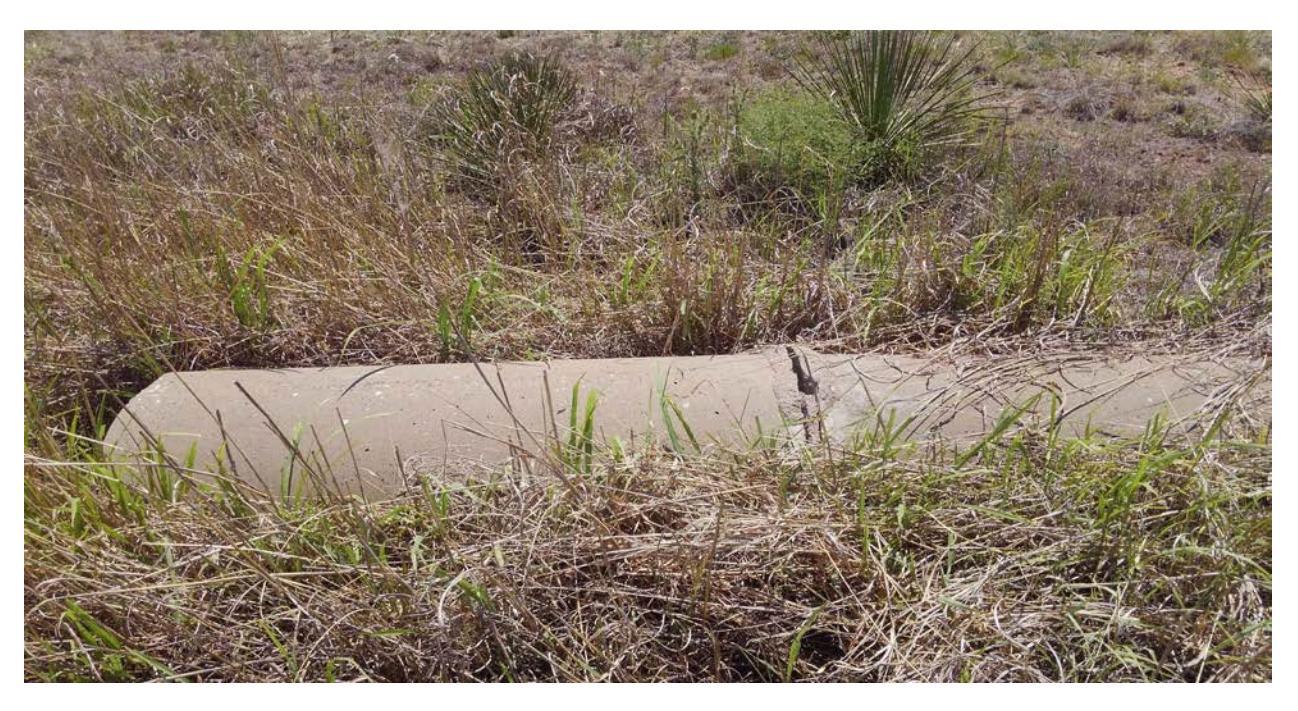
Photo 2-8. Separation in the Stormwater Line at Culvert 2

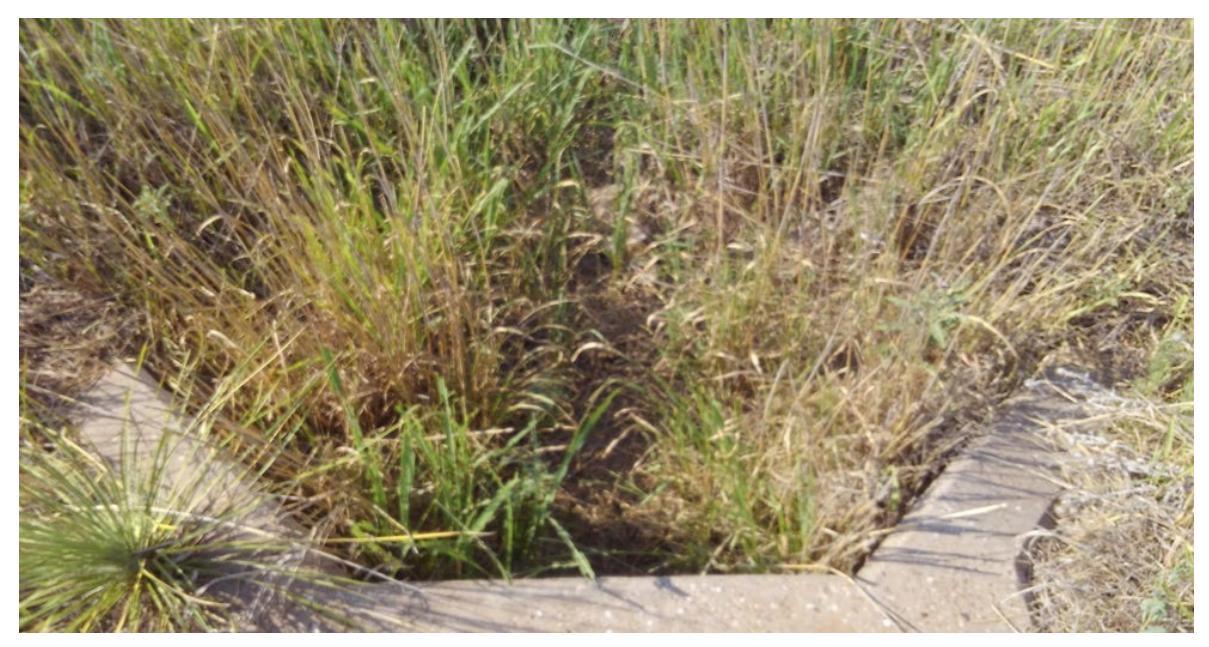
**Culvert 3.** Culvert 3 did not exhibit significant erosion; however, it was determined that grading would benefit the outfall (see **Photo 2-9**).

Photo 2-9. Culvert 3 in Overall Good Shape

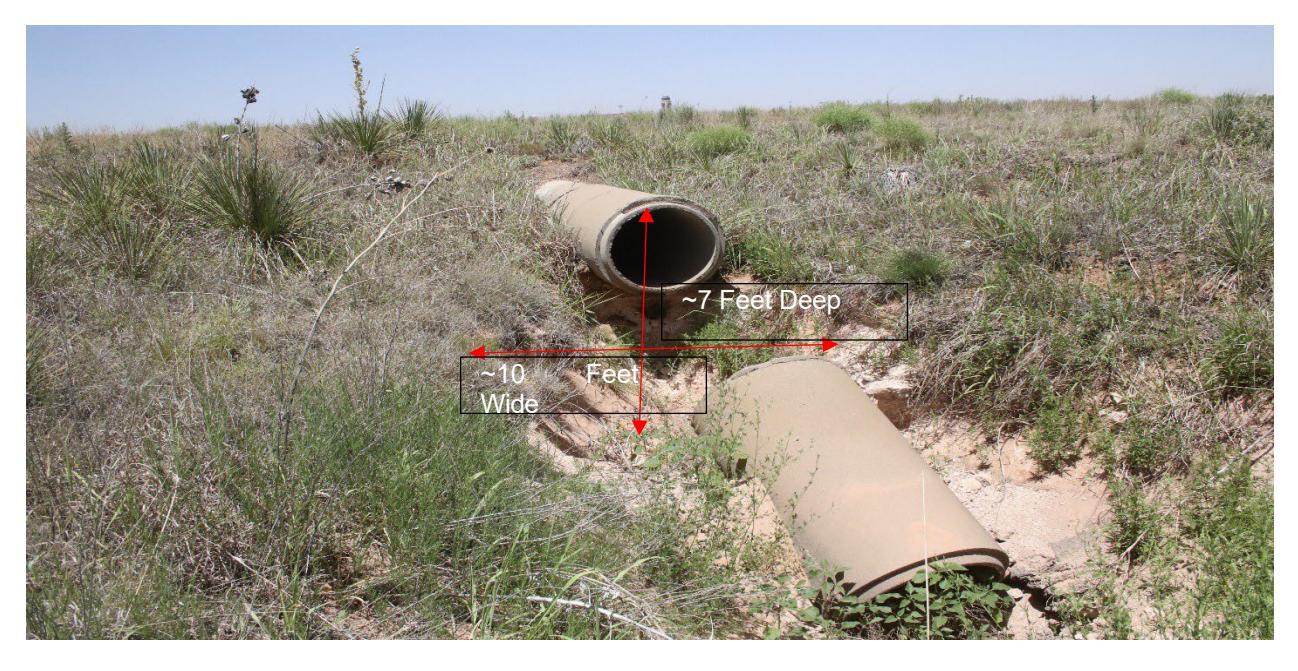
**Culvert 4.** Culvert 4 had significant erosion issues and a section of the stormwater sewer had broken off into the erosion ditch (see **Photo 2-10**). A 7-foot-deep erosion ditch that was approximately 10 feet wide was measured. The ditch ran into a 2.5-foot-deep erosion channel that contributes to the erosion issues of Culvert 5 (see **Photo 2-11**).

Photo 2-10. Culvert 4 Lost Section Due to Erosion and Subsequent Undermining

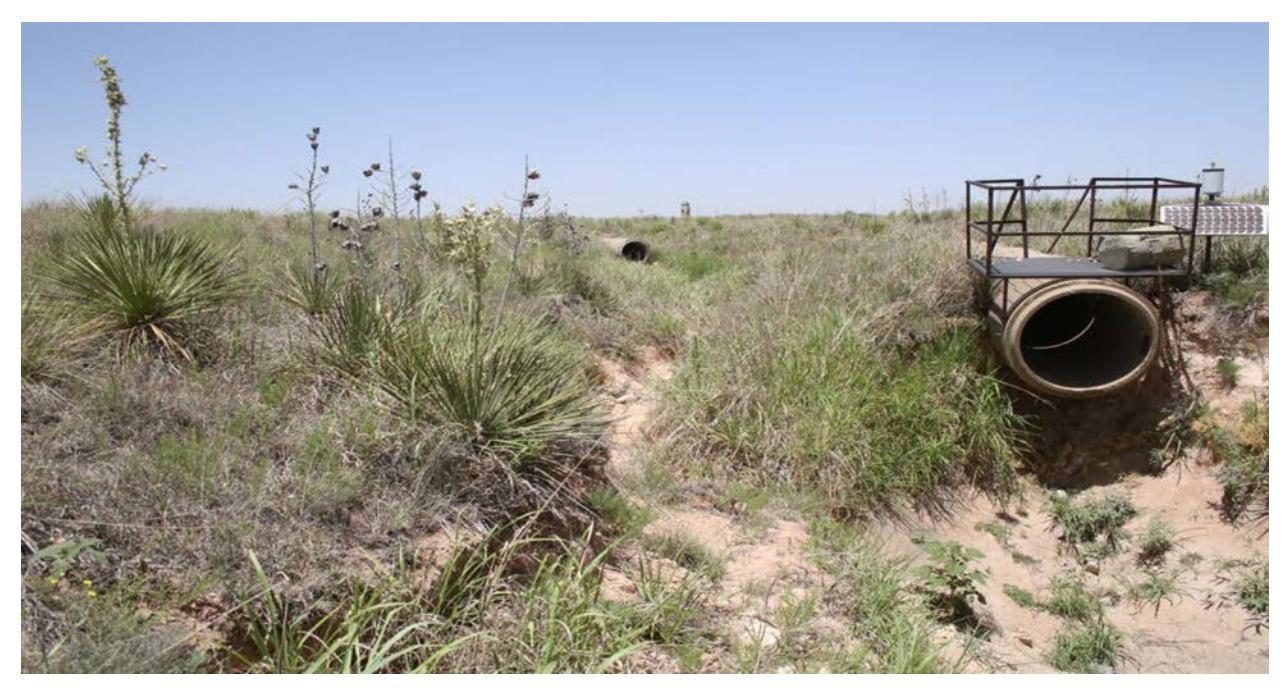
Photo 2-11. Culvert 4 (left) and Culvert 5 (right) with Erosion and Subsequent Undermining

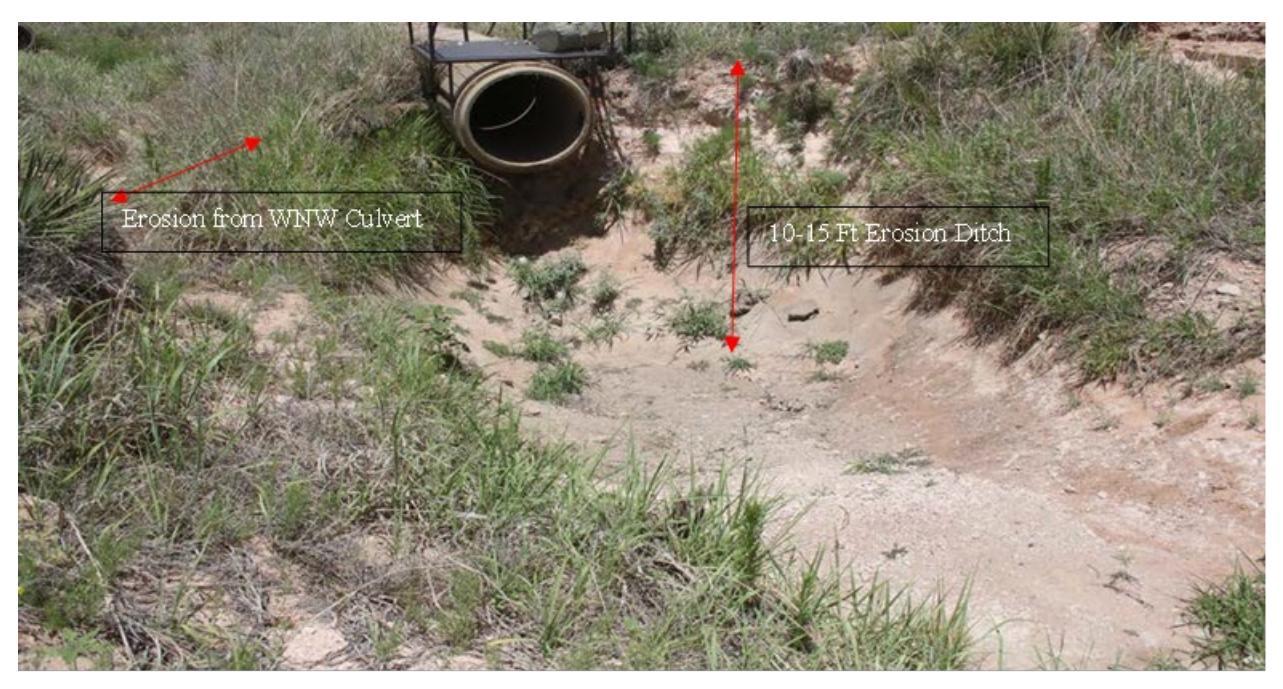
**Culvert 5.** Culvert 5 has undergone extensive erosion for many years. As of June 2020, the erosion ditch was approximately 11 feet deep (at its deepest point) and 23 feet wide (at the widest point) (see **Photo 2-12**); the trench coming out of the ditch was about 6 feet deep (at its deepest point) and 9.5 feet wide (at the widest point) and runs hundreds of feet in length (see **Photo 2-13**). An 8-inch separation was present in the length of pipe that the catwalk and flow meter are affixed to (see **Photo 2-14**).

Photo 2-12. Erosion Around and Beneath Culvert 5

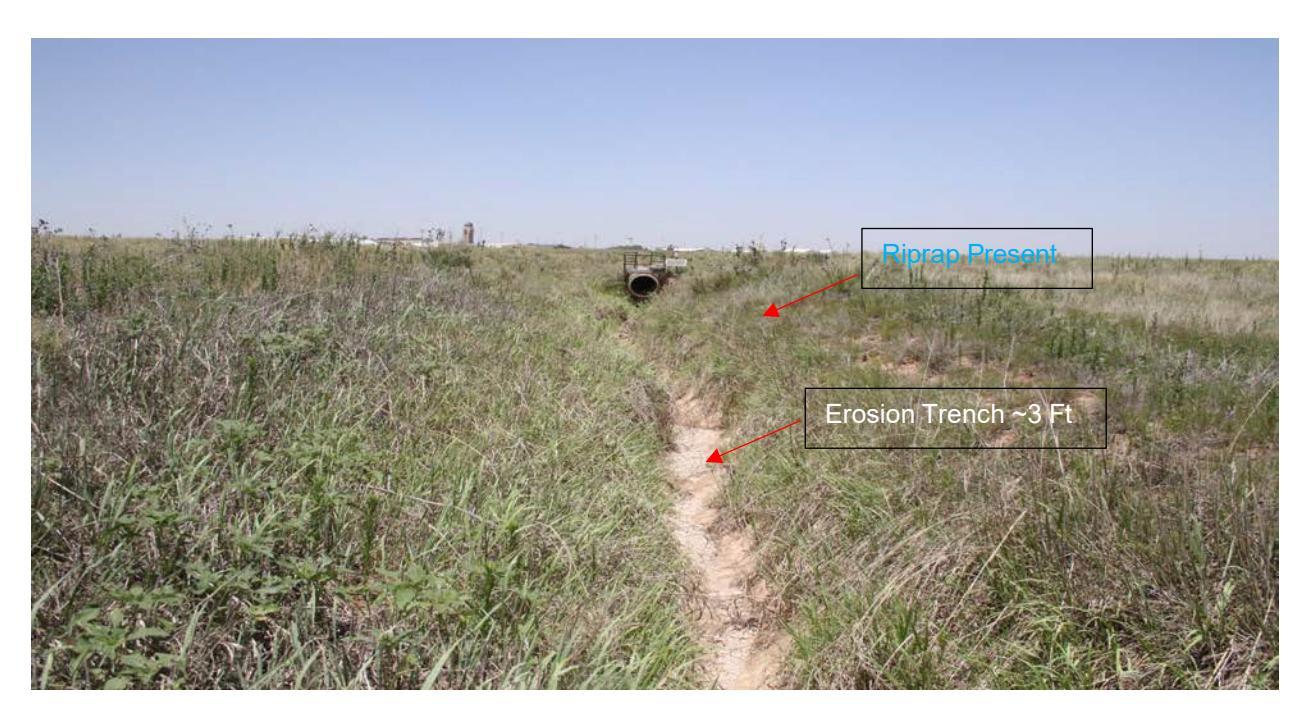
Photo 2-13. Culvert 5 and Erosion Trench

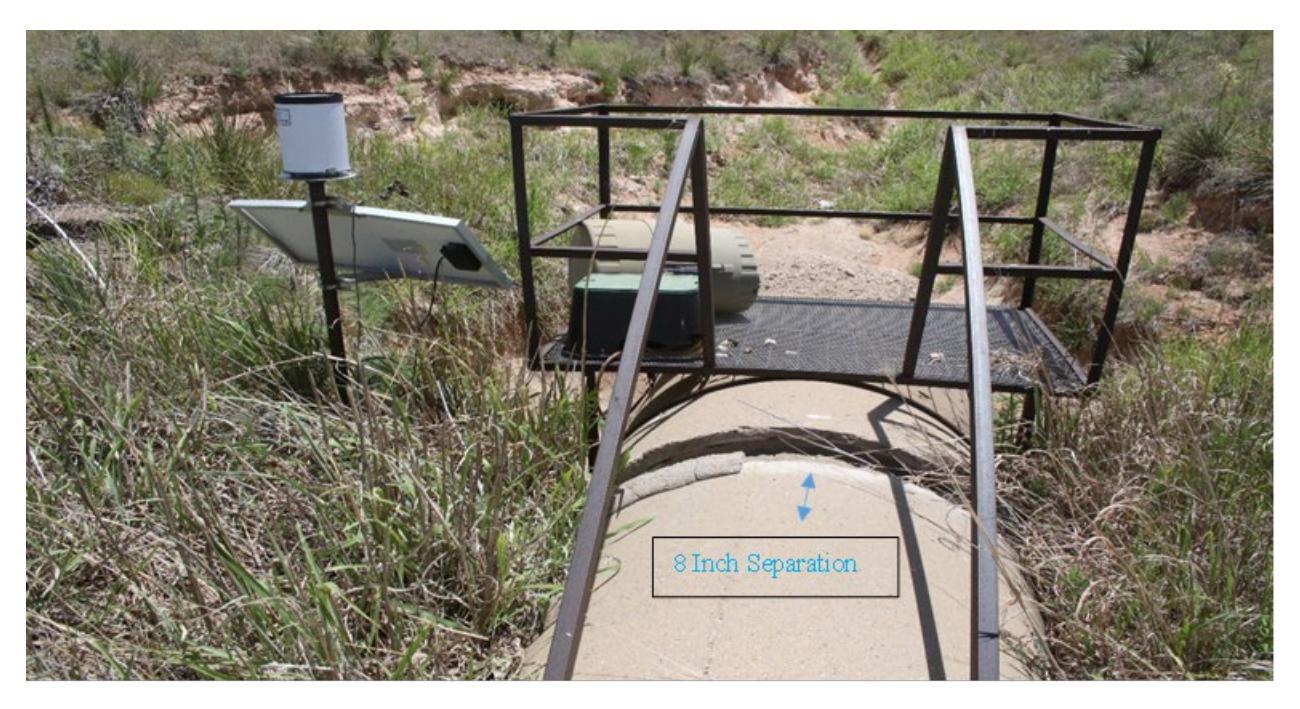
Photo 2-14. Separation in Culvert 5 Stormwater Line
