# Description of the Proposed Action and Alternatives

for the Environmental Assessment Addressing Wastewater and Stormwater Infrastructure Improvements at Cannon Air Force Base, New Mexico

Report Designation: Final Description of the Proposed Action and Alternatives (DOPAA).

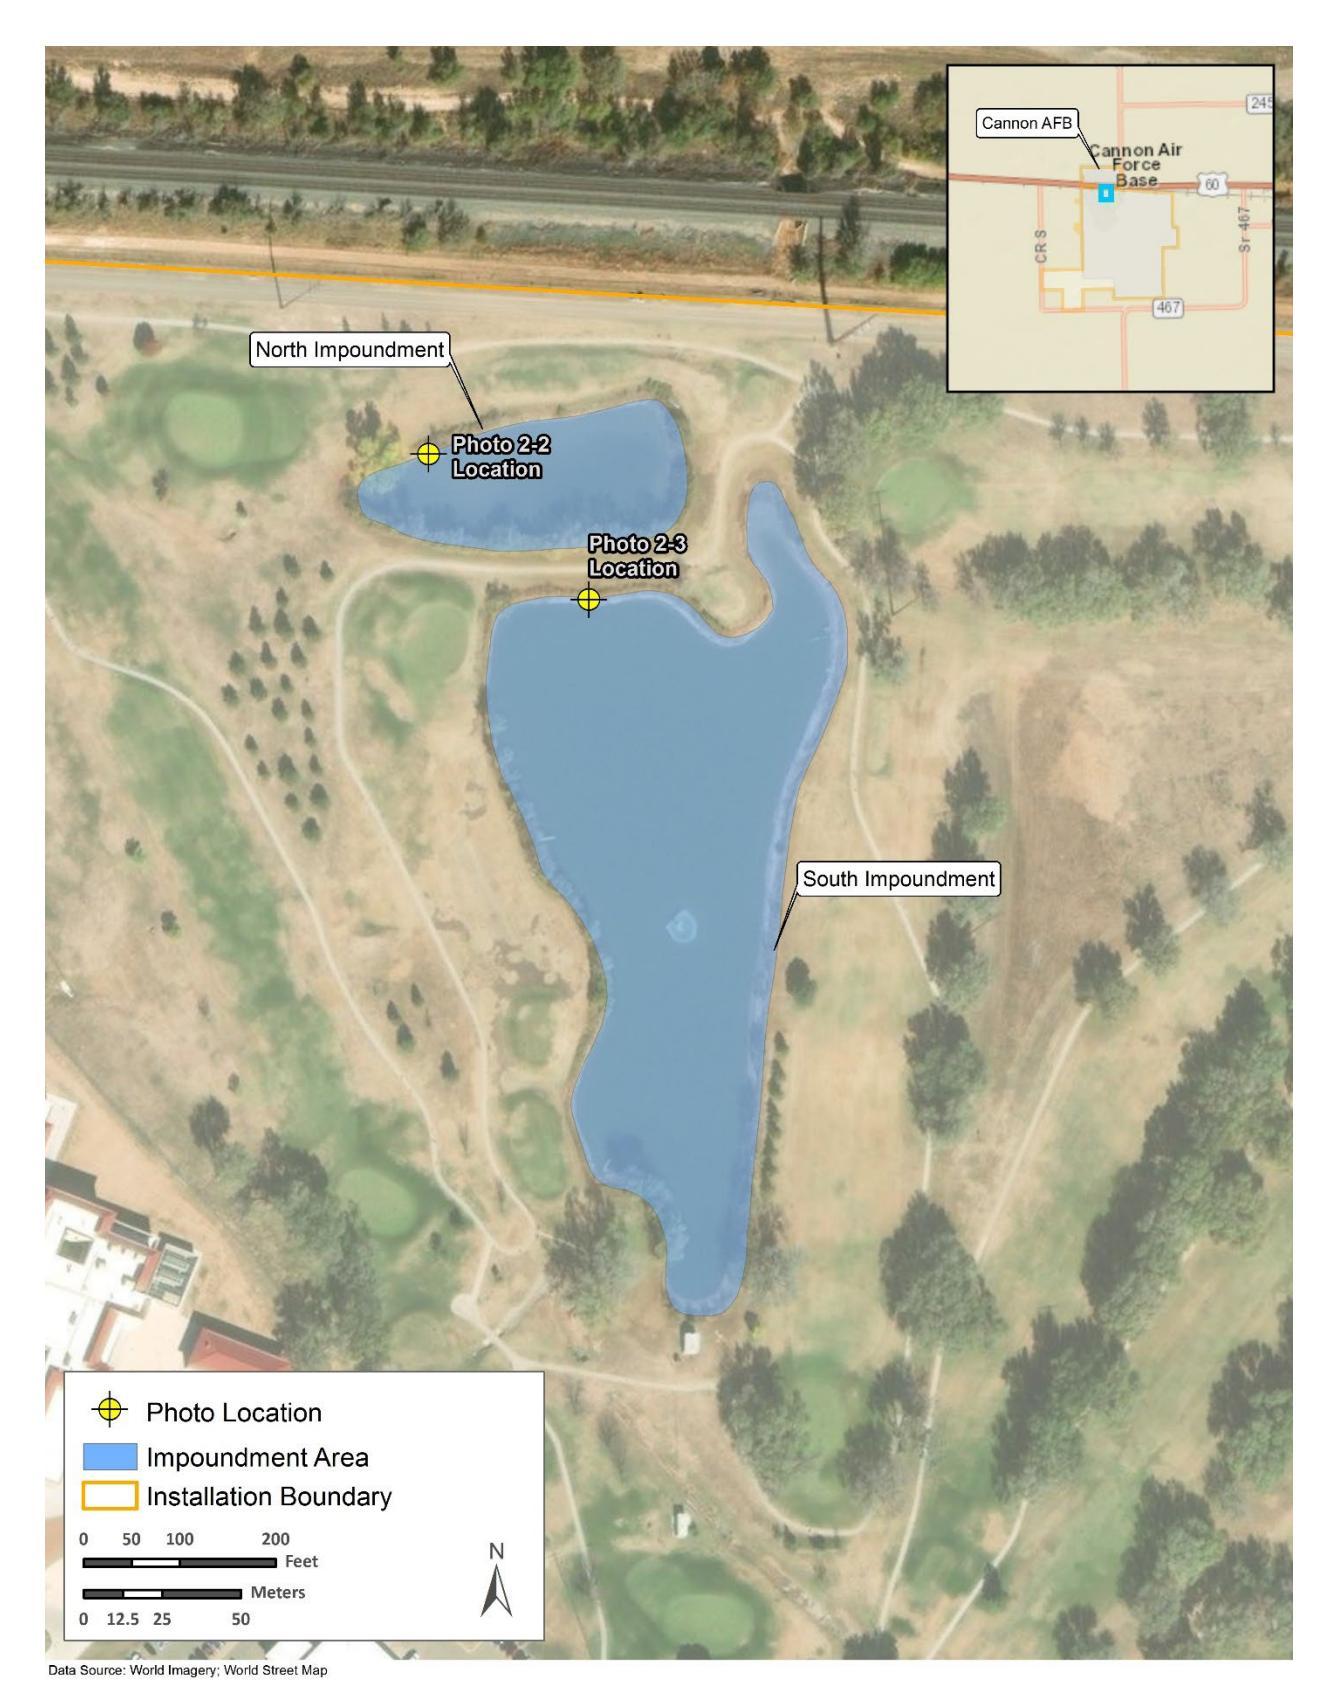
Photo 2-2. Degradation of the North Impoundment Liner

The liners in these impoundments were originally installed in 1992 and have reached the end of their life cycle. Their structural integrity has been compromised, requiring repair. The degradation, tears, and general poor condition of the liners can be seen in **Photo 2-2** (North Impoundment) and **Photo 2-3** (South Impoundment) which show damaged portions of the exposed liners. Their current condition poses a concern due to possible seepage of reclaimed water into the ground, which violates DP-873. The existing liners require replacement no later than April 2025 as indicated in the CAP required by Term and Condition 57 of DP-873 as issued by NMED. The NMED-approved CAP suggests Cannon AFB do the work in phases, similar to those listed below. However, the suggested phases are subject to change based on the final design developed by the contractor performing the work.

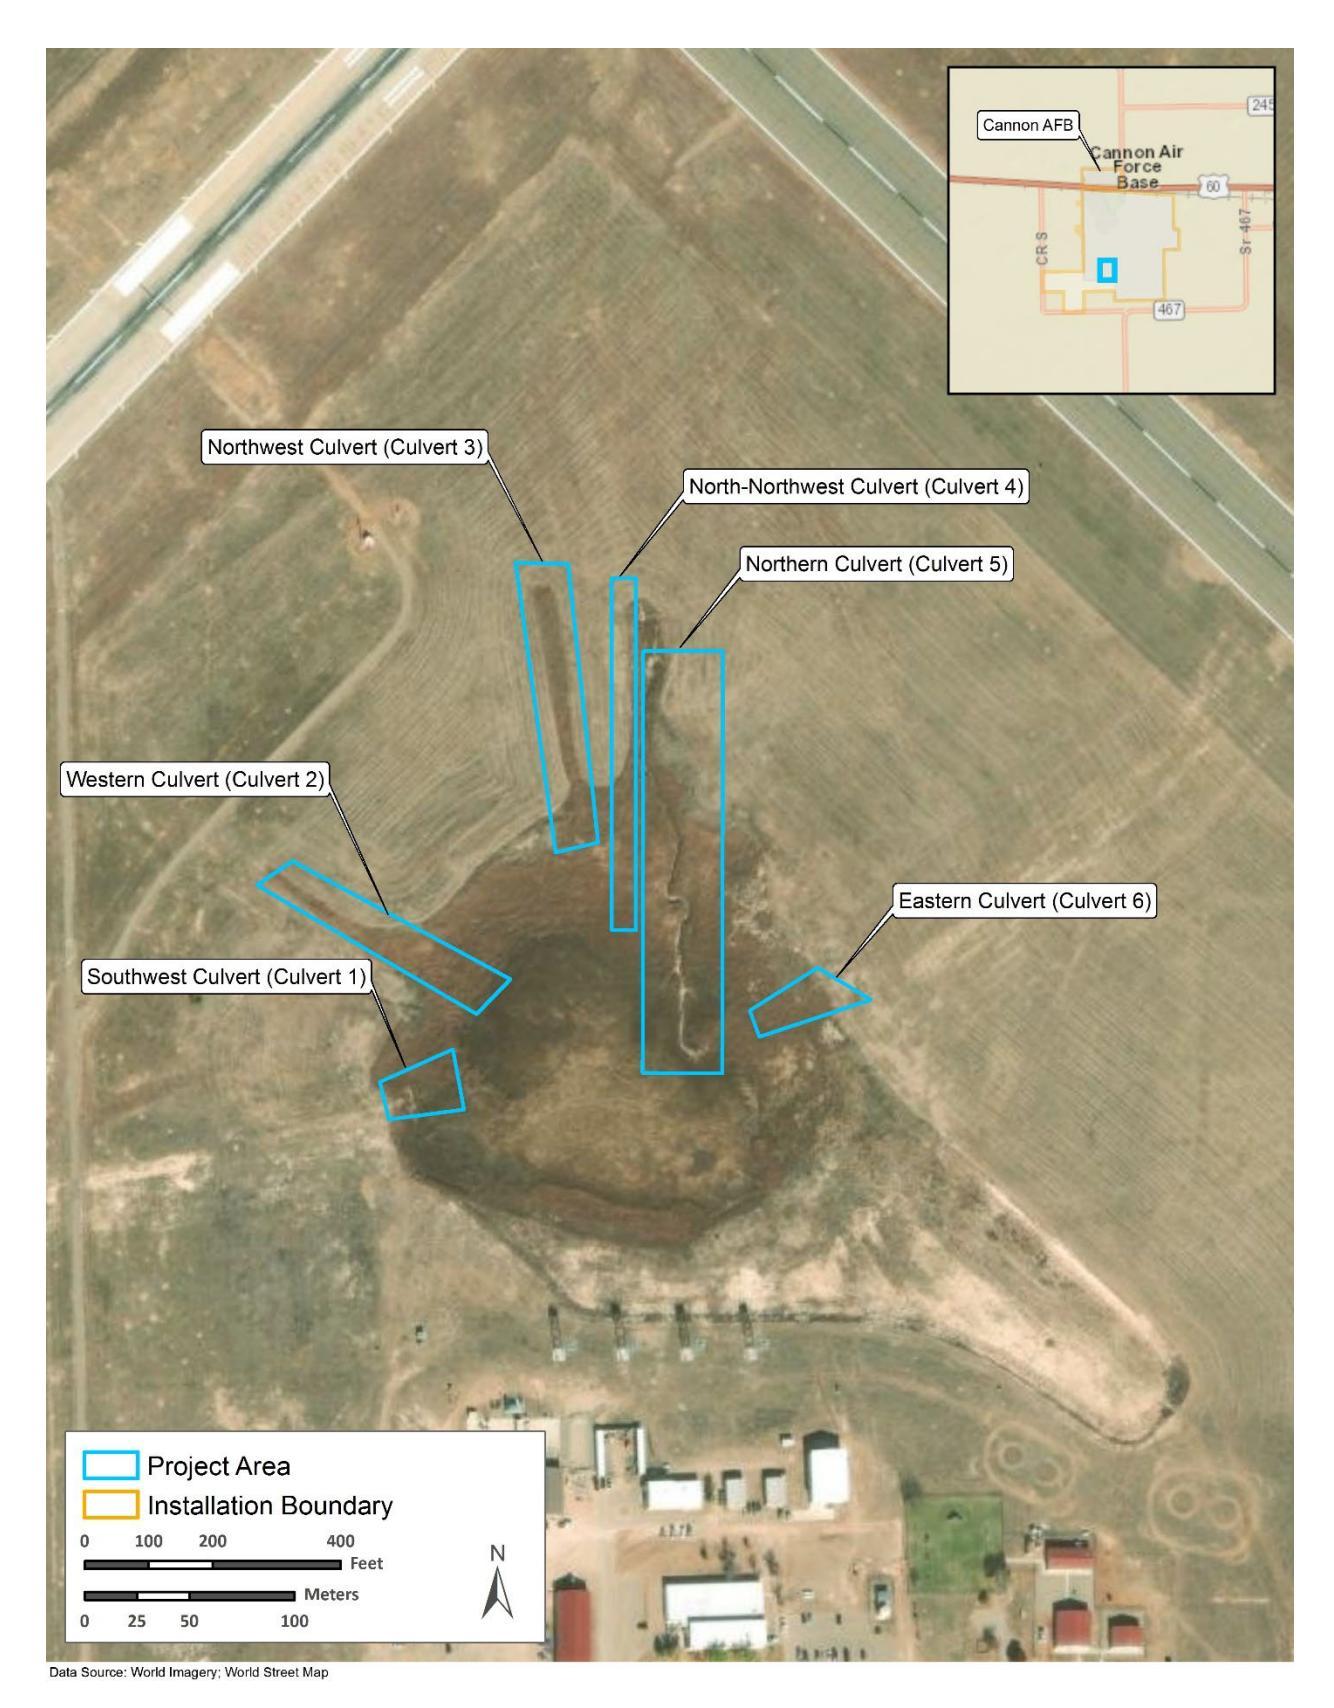
Photo 2-10. Culvert 4 Lost Section Due to Erosion and Subsequent Undermining

**Culvert 4.** Culvert 4 had significant erosion issues and a section of the stormwater sewer had broken off into the erosion ditch (see **Photo 2-10**). A 7-foot-deep erosion ditch that was approximately 10 feet wide was measured. The ditch ran into a 2.5-foot-deep erosion channel that contributes to the erosion issues of Culvert 5 (see **Photo 2-11**).
